Banjo Fitting Leak Testing Device

Senior Design Project

Report #2

Project Title: Banjo Fitting Leak Testing Device

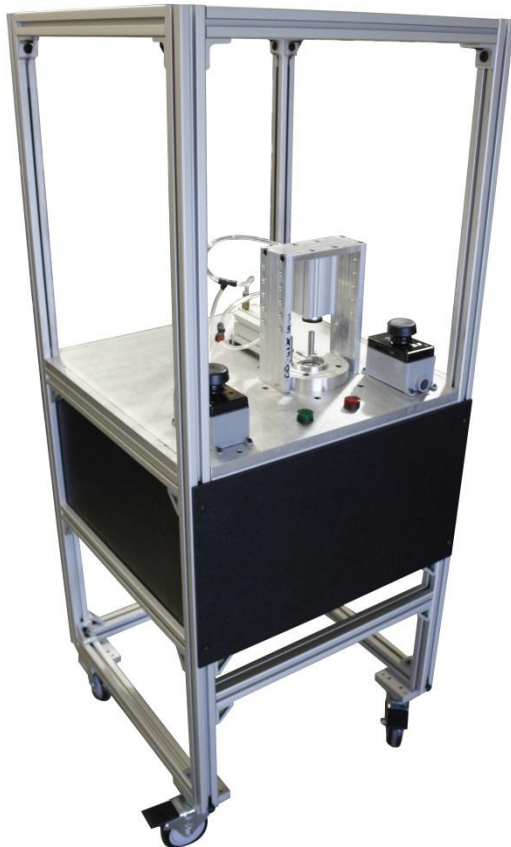
The leak testing apparatus built for EPCO Products features a partially automated design shown below. The completed apparatus is shown in figure 1 and figure 2 shows the CAD model generated during the design phase. The system requires limited operator input at a low technical level. The design calls for the operator to manually place a banjo fitting into the enclosure for testing. The base plate of the enclosure contains a “nest”, unique to each model of banjo fitting produced by EPCO. The operator places the fitting into the nest, which has been designed to provide a close fit, and ensure proper orientation during the testing procedure. The nest also acts as a device to prevent the fitting from tipping when force is applied to seal the fitting via the two cylinders.

Figure 1: Completed Assembly

Once all of those custom parts were made and the commodity parts were purchased, we began the initial assembly. Referring to Figure 1, notice the horizontal rails supporting the platform. These four pieces of 80/20 extrusion were fastened to four short scraps of the same extrusion, which were left over from an earlier project, acting as legs. This provided us with a way to elevate the platform off the work bench. It was in this configuration that the initial prototype was developed.

The final assembly consisted of assembling the 80/20 cart and replacing the temporary system components with their permanent replacements. The final steps in completing the system were installing the dual palm buttons for initiating the test, and the permanent indicating lights. A full view of the apparatus can be seen in Figure 1. A front view of the testing platform shows the portion of the device with which the operator will interact. We designed for a clean, uncluttered appearance, and this is shown in Figure 15.

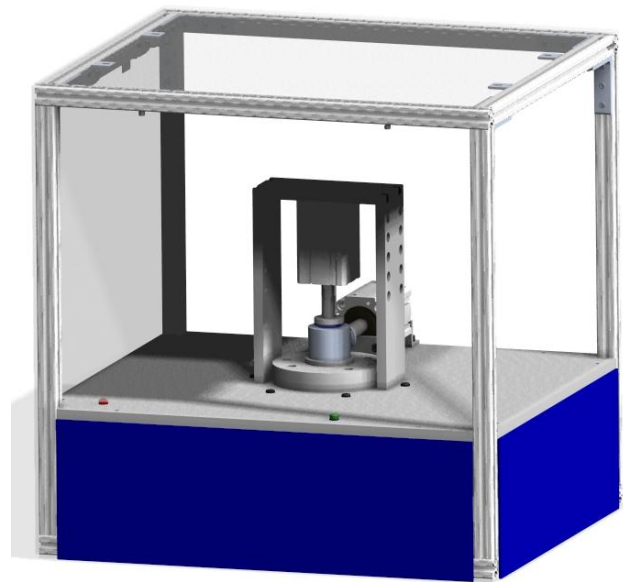
Figure 2: Original CAD Model

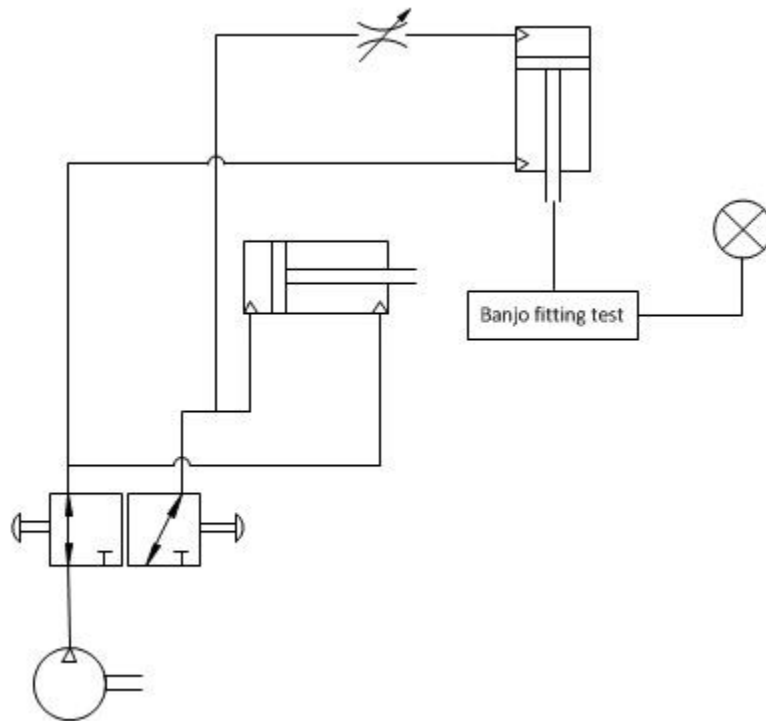
When sufficient force is applied and the fitting is sealed, a check valve opens in the vertical cylinder. This pressurizes the air in the fitting. The pressure is measured on both sides of the fitting. The leak testing device senses any minute difference in the pressure readings and signals a failed test by lighting the red LED and producing a long beep followed by a short beep. If no pressure difference is measured, the green LED indicates a passing test. Figure 3 shows a diagram of the fluid flow in the system.

Figure 3: The fluid power diagram

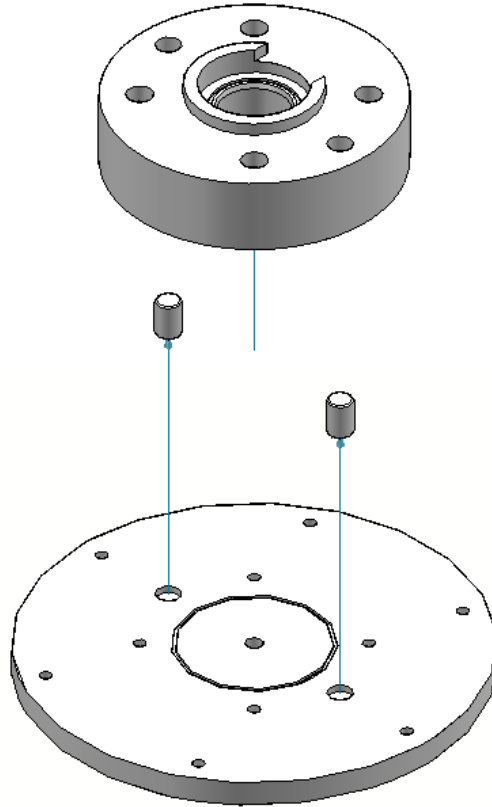
The assembly of parts designed to align and support the fittings during testing consists of the nest, manifold, and dowel pins, all shown in Figure 4. This sub assembly, shown assembled in Figure 5, is supported by the platform, as shown in Figure 6. The short brace and two long braces are assembled above the nest to form the tower on which the vertical cylinder is mounted. The horizontal cylinder is mounted to the platform using simple corner brackets.

Figure 4: The nest (top) is aligned on the manifold (bottom) via the (2) dowel pins.

Pressurized air is supplied to the manifold via a 1/8 NPT port in the bottom. A groove is cut for an O-ring to provide a static seal between the nest and manifold. The nest is joined to the manifold using four socket head cap screws. Once the assembly is complete and functioning, these four screws are all that will need to be changed to swap between different nests.

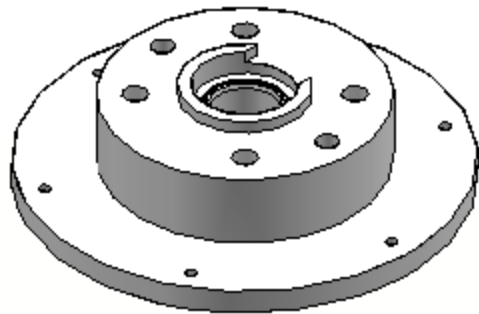
Figure 5: The nest and manifold sub assembly

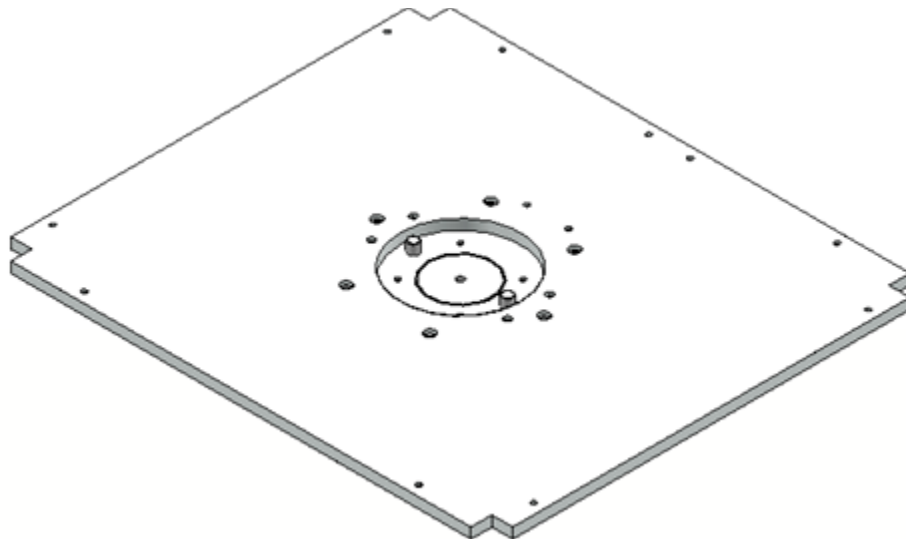
Six screws secure the nest sub assembly to the platform. The nest is not shown in this view in order to show the orientation of the manifold and dowel pins.

Figure 6: The manifold attached to the platform

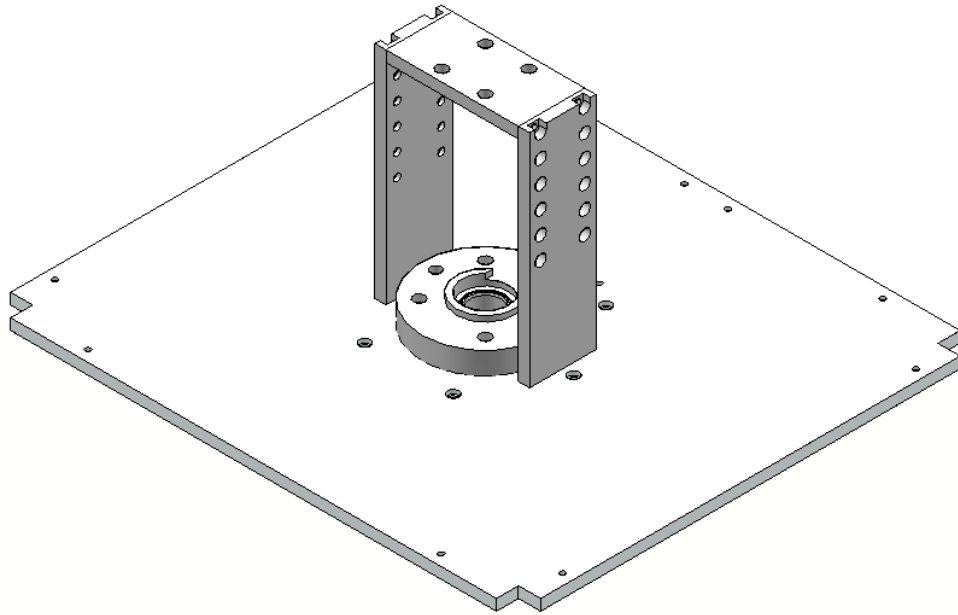
Figure 7 shows the tower assembled on top of the platform. This sub assembly will be installed in the enclosure. The cylinders are mounted in the appropriate positions, and the leak tester is installed per instructions from the manufacturer.

Figure 7: The assembly ready for the installation into the enclosure

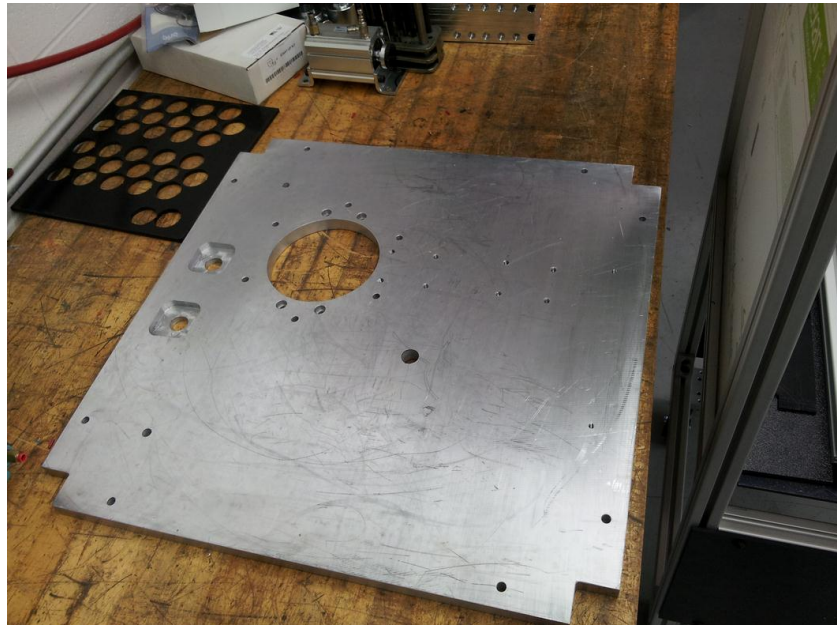
The largest and most expensive component of the design is the testing platform. We did not oversee the machining of this piece. The sponsor used a preferred vendor, as the CNC mill available to us would not accommodate the 2' x 2' size of the platform. A technical drawing was not necessary for the platform. We supplied the sponsor with an accurate CAD model of the platform, which was used by the vendor to create the CNC code directly from the model's geometry. No manual programming was needed. Figure 8 shows the machined testing platform with a few modifications made during the build process.

Figure 8: Underside of the machined testing platform

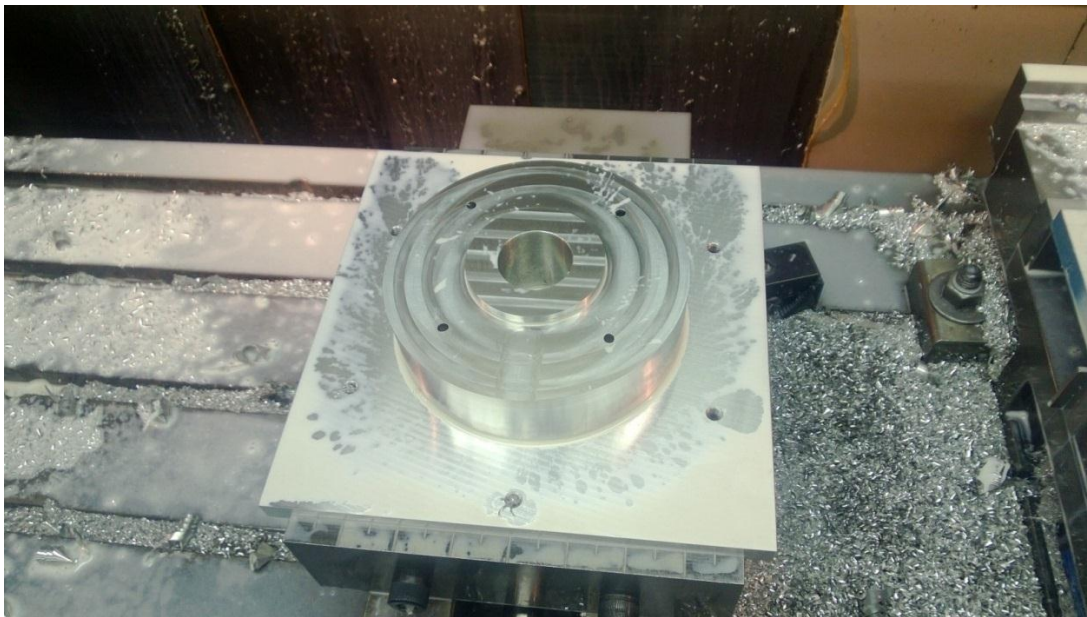
The nest has a circular profile, which necessitated a fixture for machining in the mill. Since the manifold was produced with a square profile, and the two pieces were aligned with precision fit dowel pins, the manifold served a dual purpose as both a finished part and the nest fixture. The nest, approximately 60 percent complete, is shown in Figure 9. The square of aluminum underneath is the manifold acting as a fixture.

Figure 9: Machining of the Nest

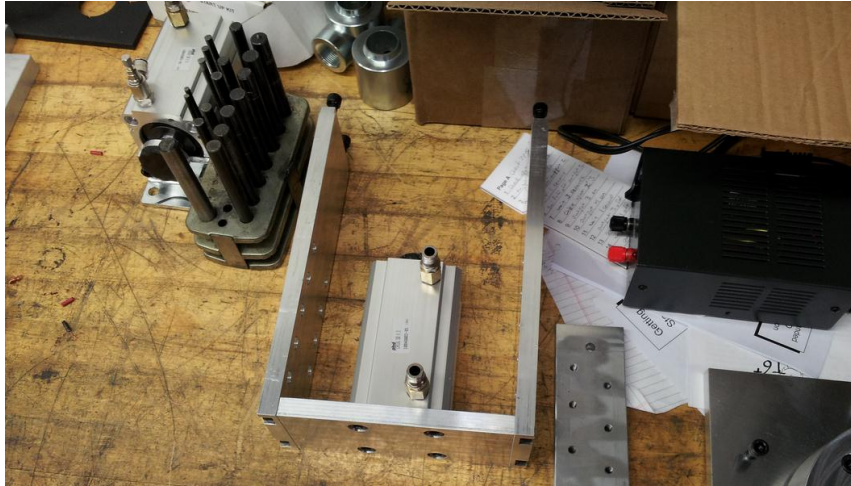
The support structure for the vertical cylinder, shown in Figure 10, must be fastened to the platform first. It is secured from the bottom of the platform using four socket head cap screws (SHCS). The manifold that supports the nest is then secured to the underside of the testing platform using six SHCS. The appropriate O-ring was placed in the groove on the manifold, and the nest was then installed and secured to the manifold. It is critical that the alignment cutout in the nest be oriented toward the mounting holes for the horizontal pneumatic cylinder this cylinder is mounted to the testing platform with foot mount brackets.

Figure 10: Vertical cylinder mounted to the support structure prior to assembly

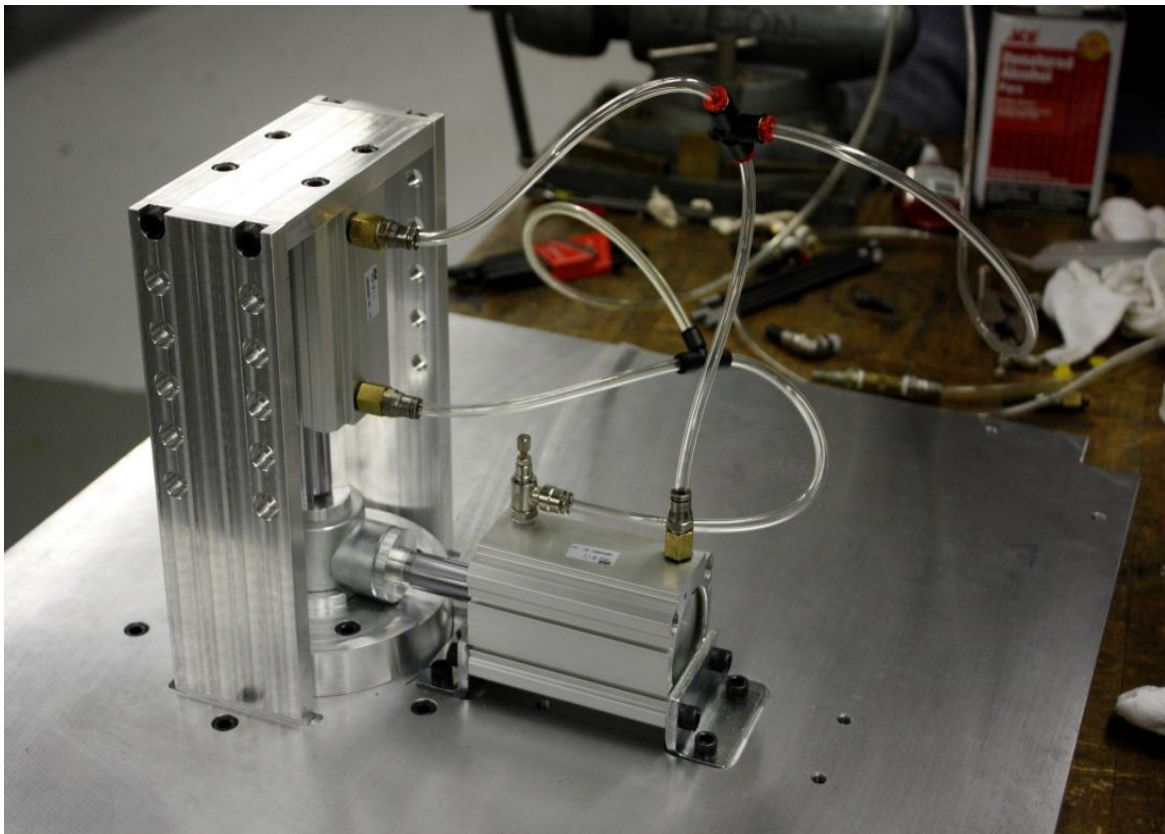
At this point, manually actuated pneumatic valves were connected to the cylinders to test the alignment of the assembly. Notice in Figure 11 that the cylinders are extended to the point that they contact the banjo fitting, showing that they will provide a proper seal once the polyurethane caps are installed.

Figure 11: The first mockup of the system

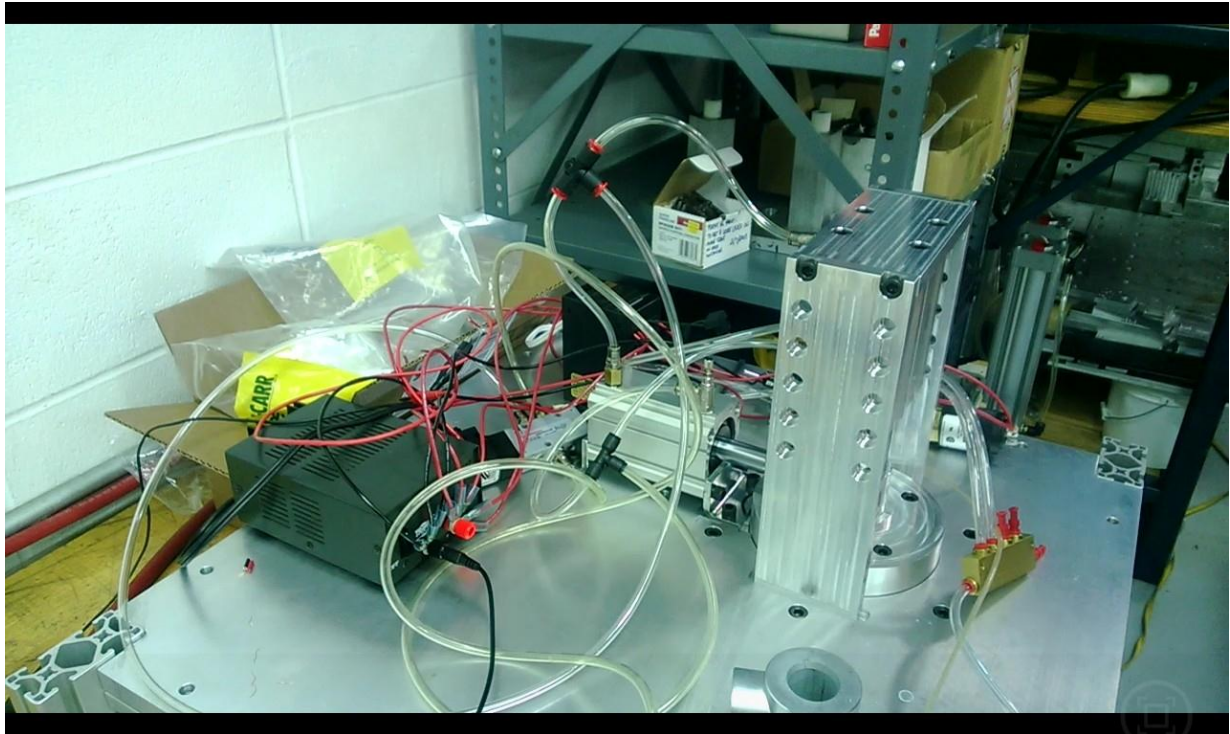
In order to complete a working prototype, the testing system was assembled and installed using mostly permanent parts, as well as some temporary substitutions. This system is described in detail in Section II.v. The first functioning prototype is pictured in Figure 12. This prototype produced an accurate test on the first trial.

Figure 12: The initial prototype

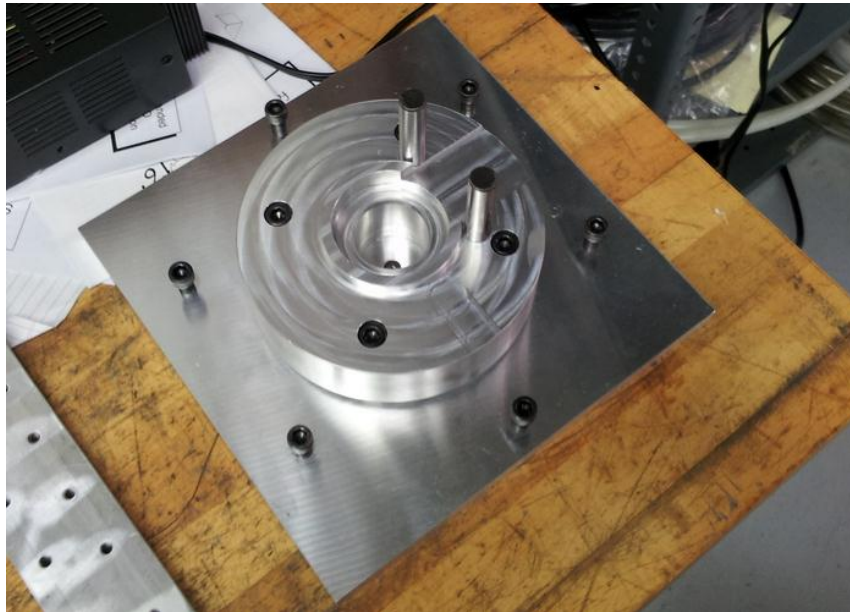
During the building process there were a couple minor modifications made to the design. Early on in the testing it was discovered that the hardness of our rubber tips for the cylinders was not going to be good enough. The pressure of the cylinders was causing the rubber to deform quite a bit and we decided this could cause problems after many cycles. To begin with we were using 60 Shore rubber, and after our test results we increased the rubber tips to a 90 Shore hardness. We also opted to go with a larger more beefy O-ring in the nest, to withstand the wear and tear put on it from many cycles. The original height of the testing platform from the floor seemed like it may be a problem for the user. It was low enough that it could cause the user to lean over too much and create back problems. It was also at a height where the line of vision from the user would be obstructed by the top bar of the 80/20 case. Due to both of these issues, the height of the platform was raised by 5 inches after consulting with Bill Johnson of EPCO Products. In our testing we also realized that the original cutout we were using to aid in alignment of the banjo fitting was not going to work the way we wanted it to. To take care of this issue, two small vertical dowel pins were added on the top of the nest so that the horizontal part of the banjo fitting could be placed in the exact position needed for alignment with the side hydraulic cylinder. The nest with added dowel pins is shown in Figure 13.

Figure 13: Nest with Dowel Pins for Alignment

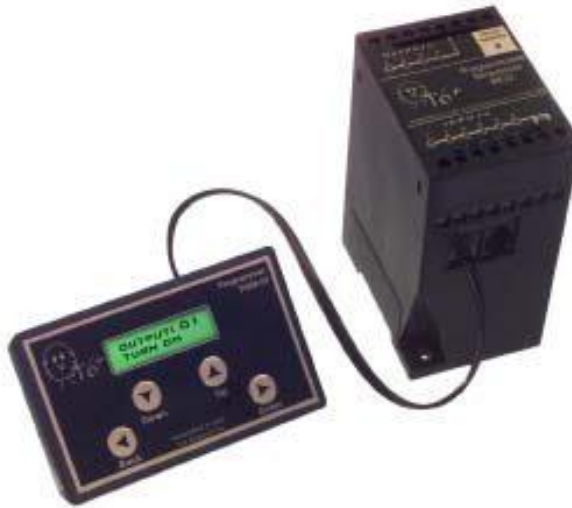
After the group began building the machine, we quickly realized that the use of some sort of logic controller was inevitable. Using a PLC presented a challenge because none of the group members had programmed a PLC controller before, nor had Bill Johnson at EPCO products. The goal was to find a relatively inexpensive PLC programmer that we could program easily and could be easily modified by an employee at EPCO products. We decided to go with a Trol systems T6 microcontroller, as seen in figure 14, with a detachable handheld programmer and expansion module.

The Trol systems T6 microcontroller had six inputs and four outputs and could output both DC and AC power. The expansion module provided us with an *additional* six inputs and four outputs which was more than we needed to meet the requirements of the project. Using a logic controller with a handheld programmer would ease the programming and modification in the future.

Figure 14: Trol Systems T6 microcontroller.

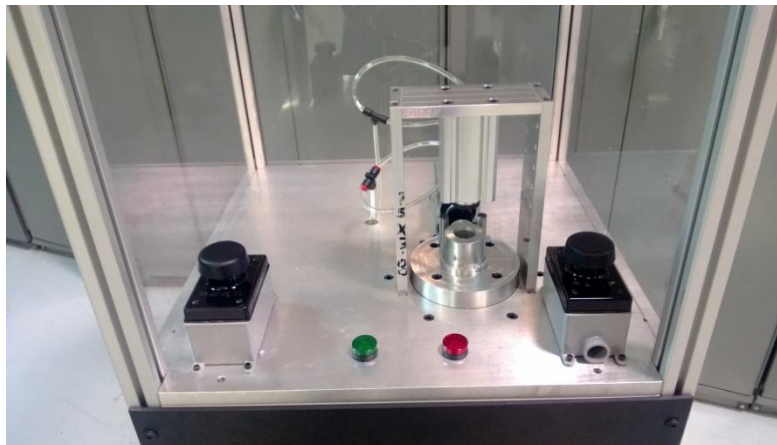
Figure 15: The final assembly
